PHOENIX™ - SUPPORT ELEMENT NOT FIXED TO ROOF

TBA PROTECTIVE TECHNOLOGIES LTD

P - 020

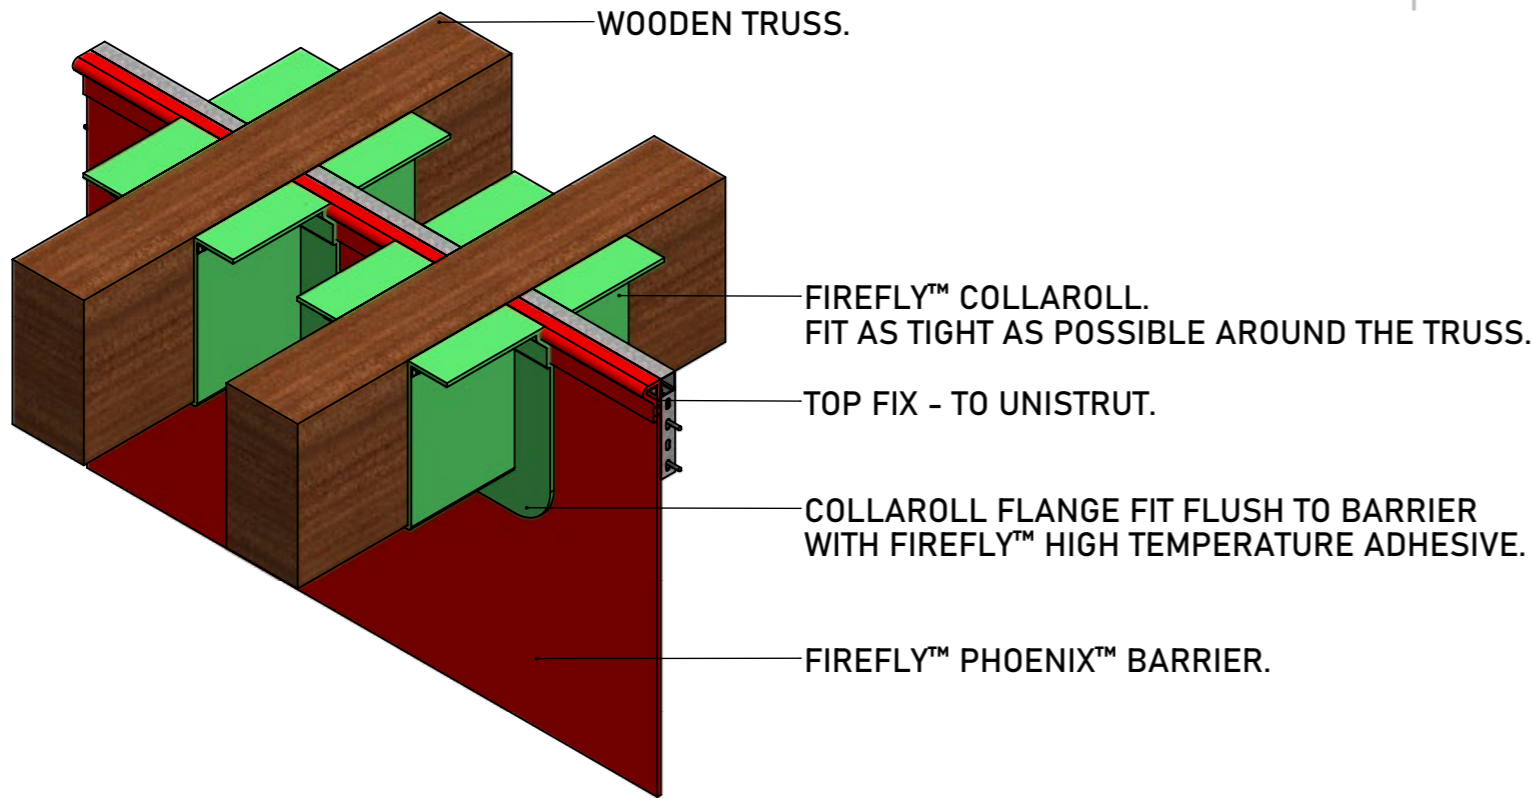
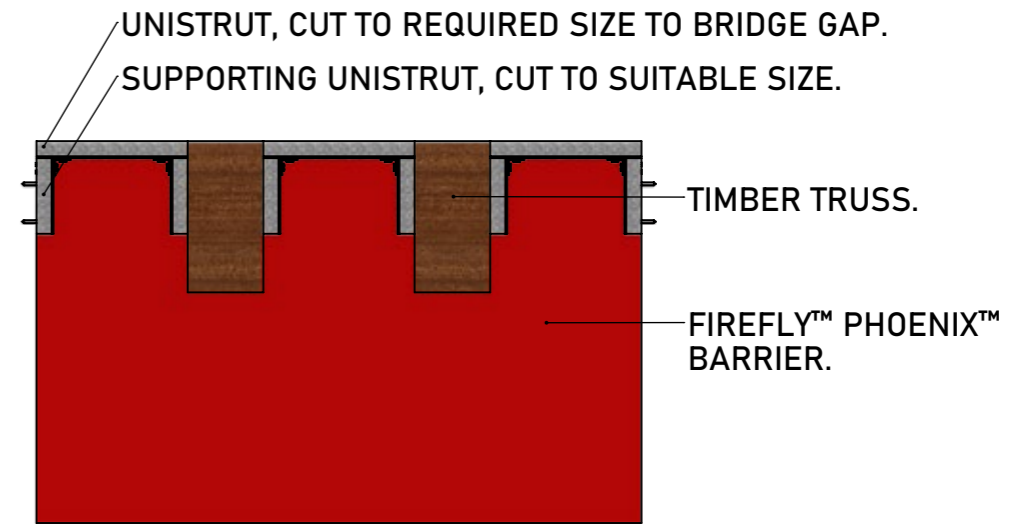
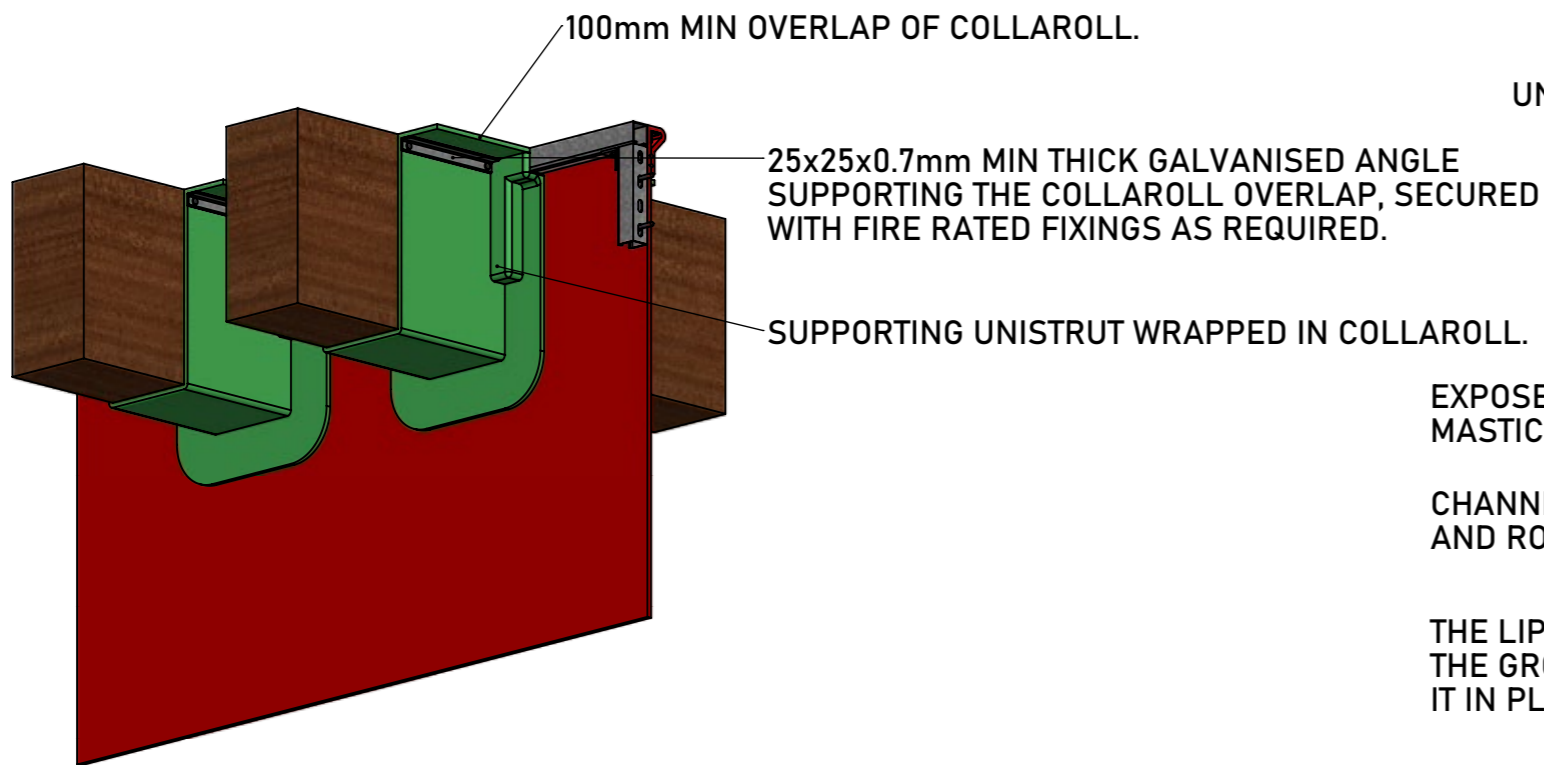
SUPPORT DETAILS.

EXPOSED TRUSS COATED IN ACRYLIC MASTIC AFTER INSTALL.

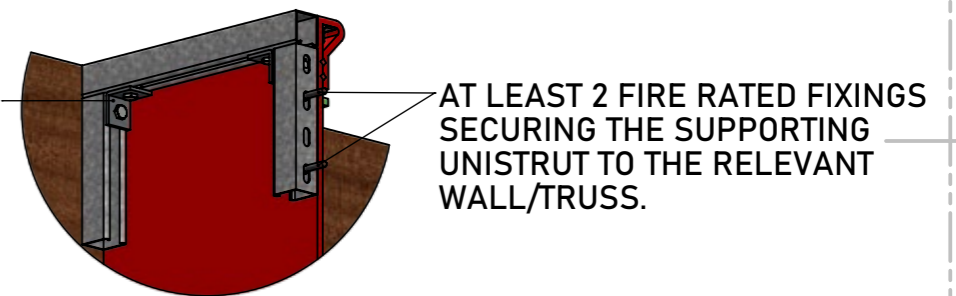
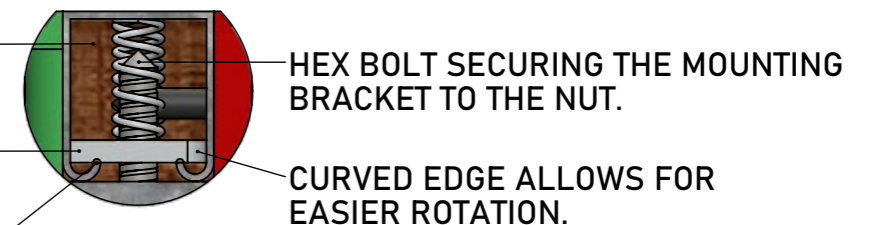
UNISTRUT MOUNTING BRACKET.

CHANNEL NUT INSERTED FIRST AND ROTATED INTO LOCK POSITION.

THE LIP OF THE UNISTRUT SLOTS INTO THE GROOVE OF THE NUT ANCHORING IT IN PLACE.

LOCKING THE NUT WILL STABILIZE THE FIXING AND STRENGTHENS THE STRUCTURAL INTEGRITY OF THE UNISTRUT.
